Kennecott
Utah Copper
P.O. Box 525
Bingham Canyon, Utah 84006-0525
(801) 569-6555

July 26, 1991

Subject: Tailings Pond Stability

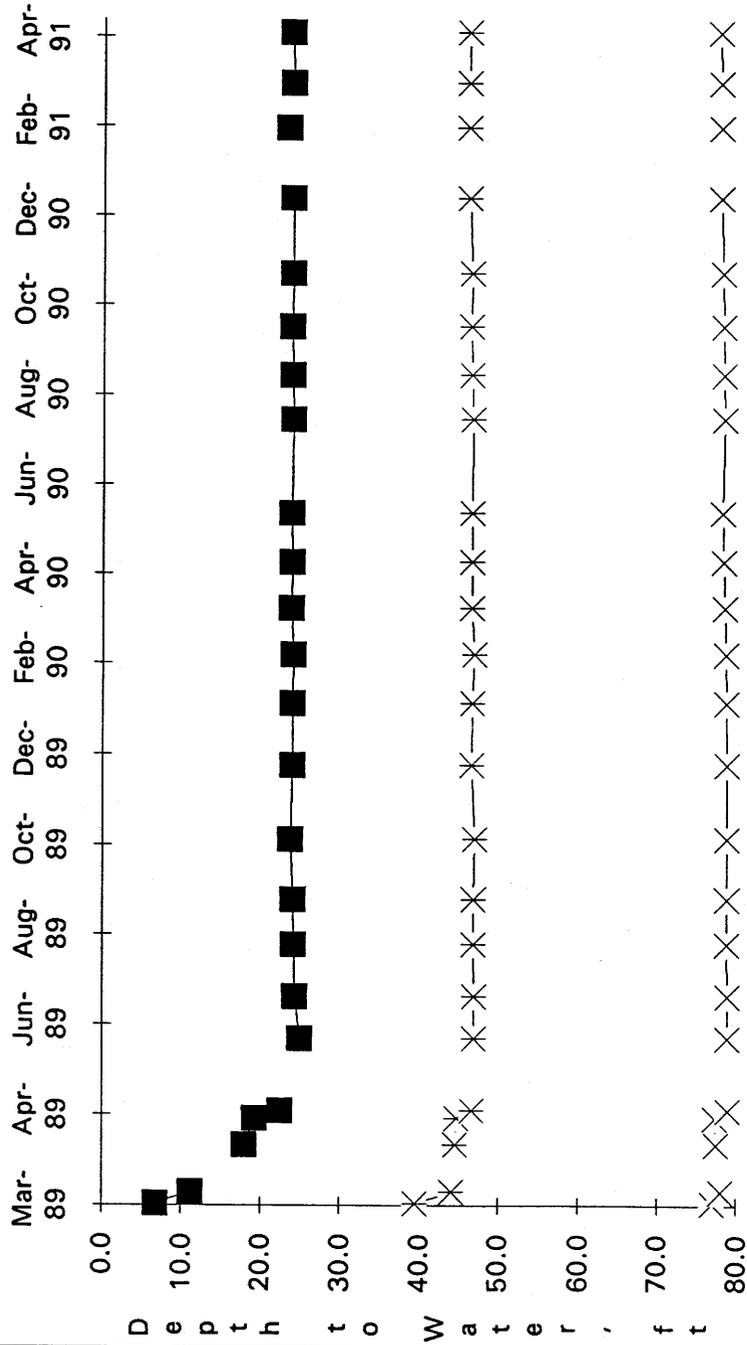
Section A - Piezometer Trends

Attached for your information are graphs of the monthly measurements of the piezometers in the tailings impoundment. As you can see, the trends show continued, and in some areas, increasing stability of the impoundment.
